BY JANE FORSYTH (INSTITUTE OF GEOLOGICAL & NUCLEAR SCIENCES), ELIZABETH CLARK (WELLINGTON CITY COUNCIL, SECONDED TO GNS) AND JULIA BECKER (FORMERLY INSTITUTE OF GEOLOGICAL & NUCLEAR SCIENCES)

1999 QUEENSTOWN FLOODS

OVER THE LAST FIVE YEARS PLANS HAVE BEEN PUT IN PLACE AND THE COMMUNITY IS MORE AWARE OF FLOOD RISK AND MITIGATION STRATEGIES THAN BEFORE 1999

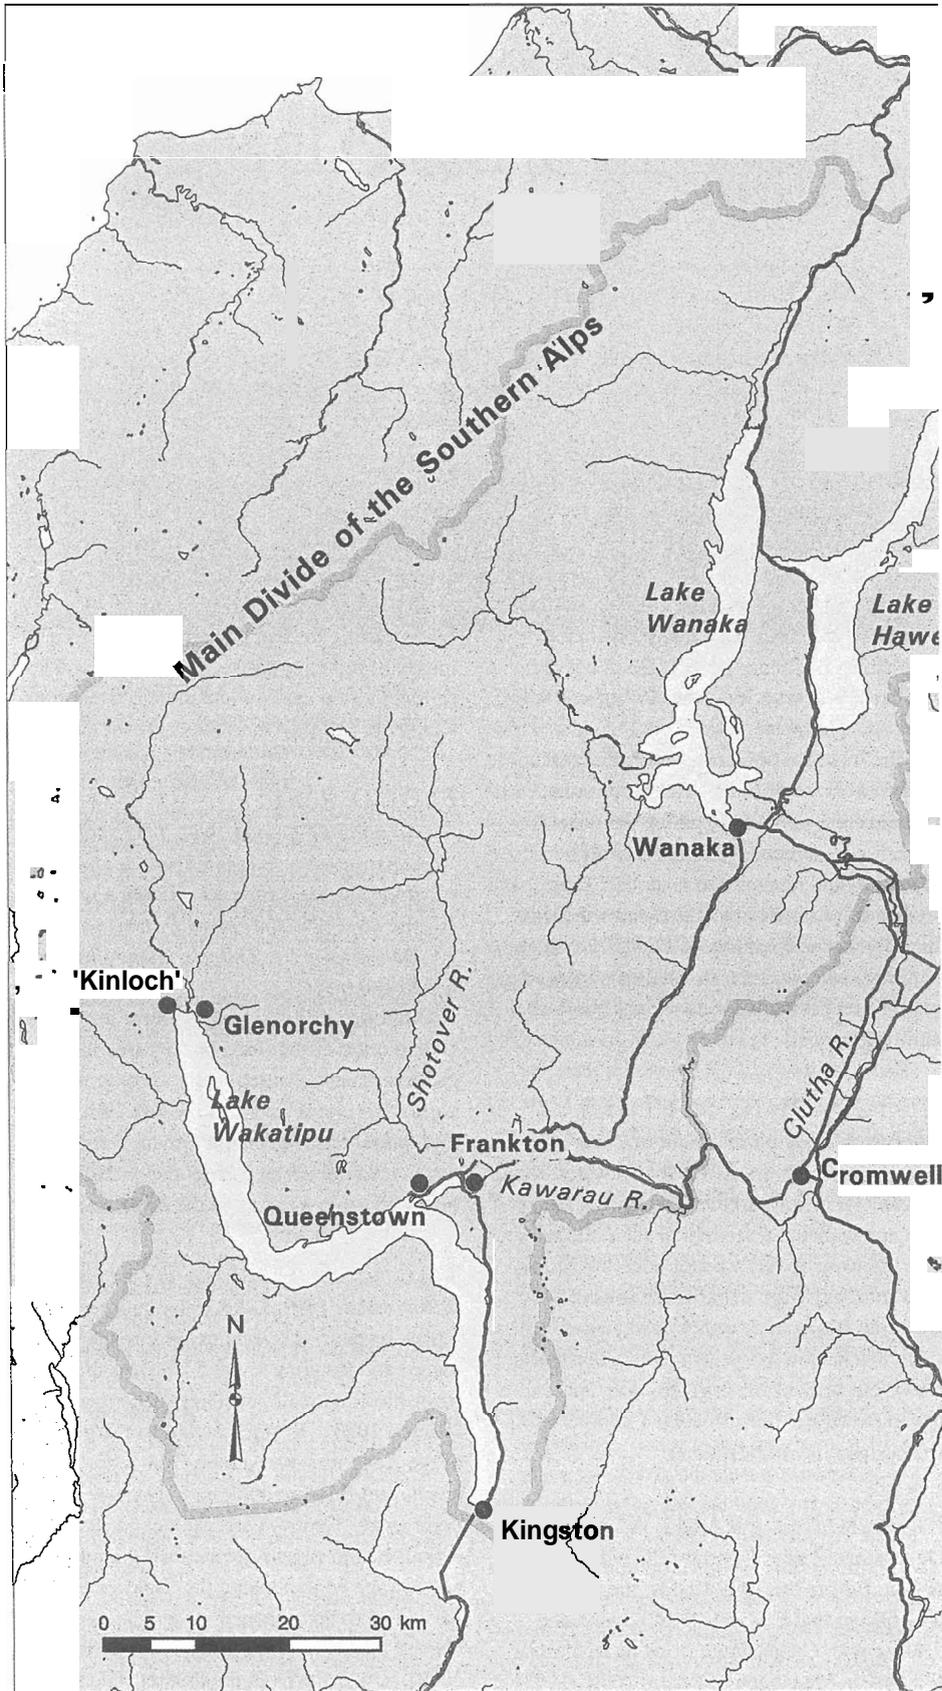
Queenstown lies on the shore of Lake Wakatipu, which drains via the Kawarau River (Figure 1). Inflows to the lake, during heavy rain and snowmelt, are higher than outflows. The Shotover River, a major tributary of the Kawarau, has large delta which impedes Kawarau flows, and further downstream there is a narrow gorge which also constricts flows. Because of these geographic factors, Queenstown has been flooded a number of times since its establishment.

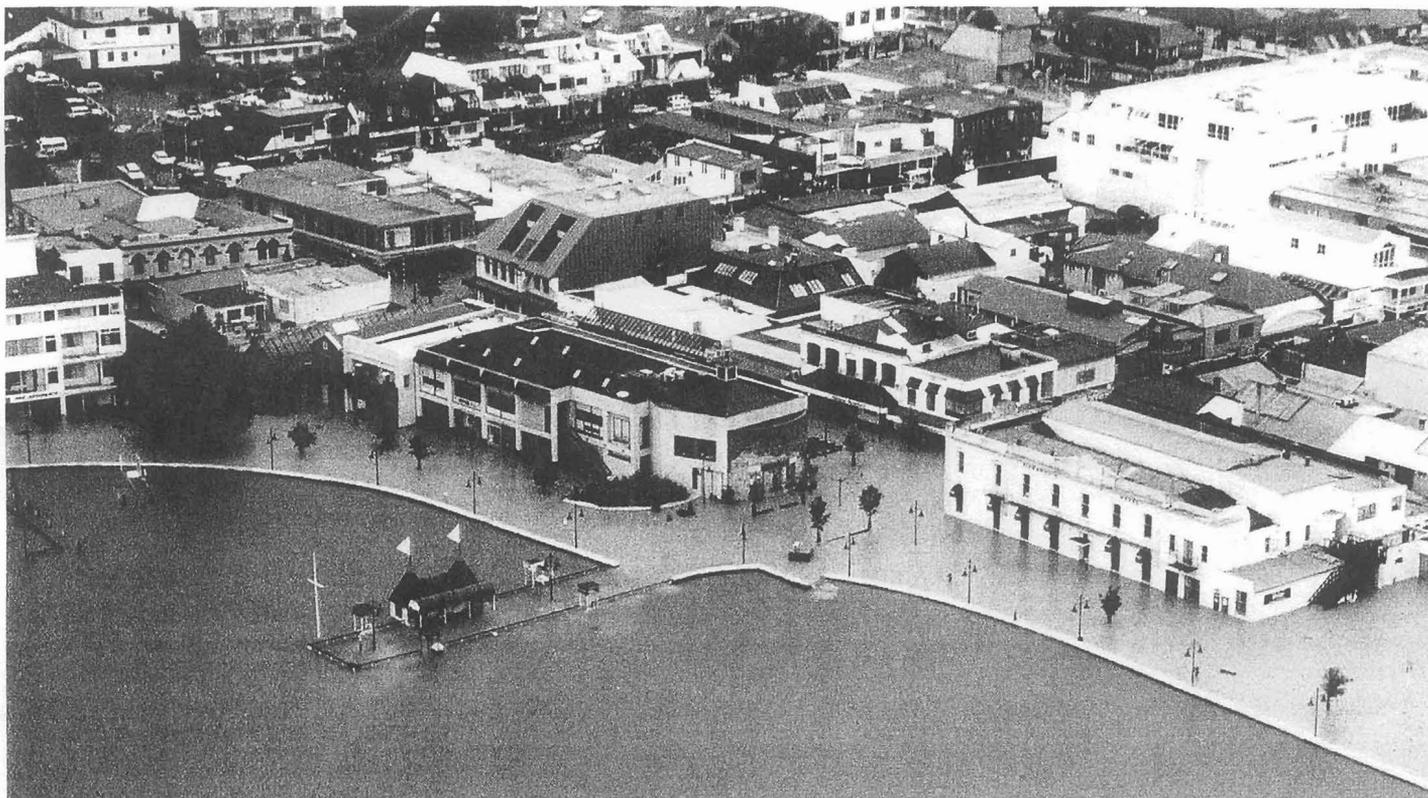
In November 1999, Lake Wakatipu reached a peak level of 312.78m, exceeding the 1878 record and flooding about 5 hectares of the township (Figures 2, 3) (Otago Regional Council 2000). In some locations the peak of the flood was over a metre above floor levels, and flooding took up to two weeks to drain away. Central Queenstown became a serious health risk as decomposing mud, food and sewage contaminated the floodwaters. Areas had to be cordoned off and people were warned to stay away (Becker & Richardson 2000). Other towns in the district (Glenorchy,

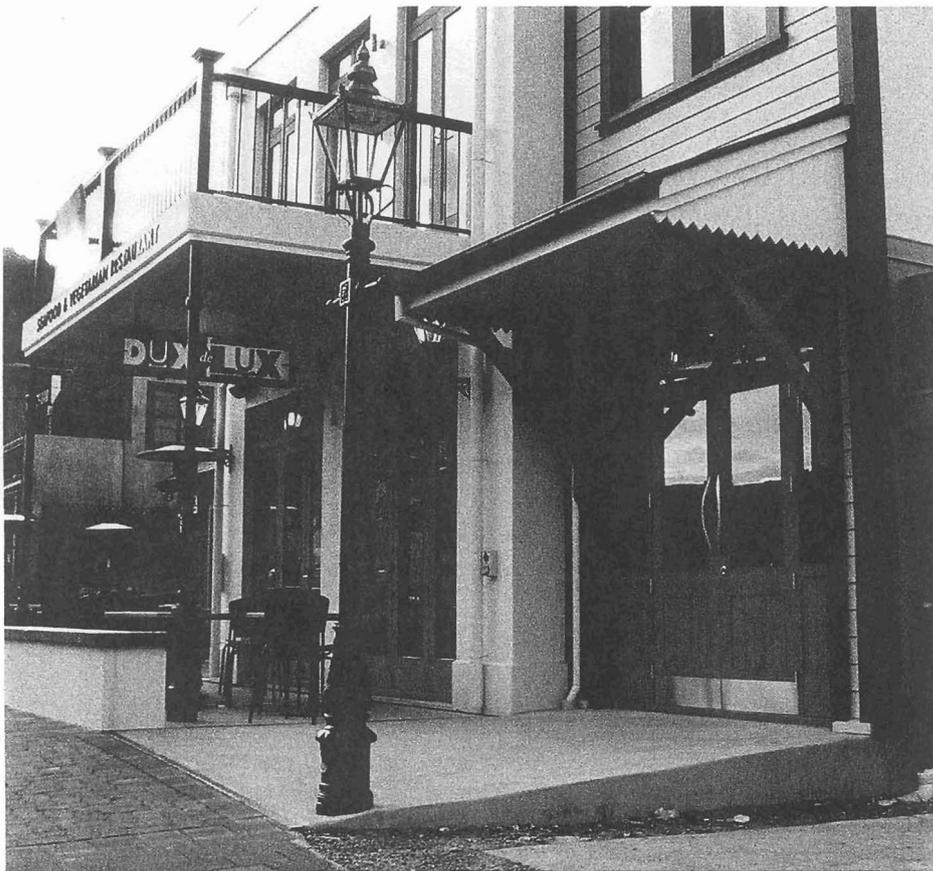
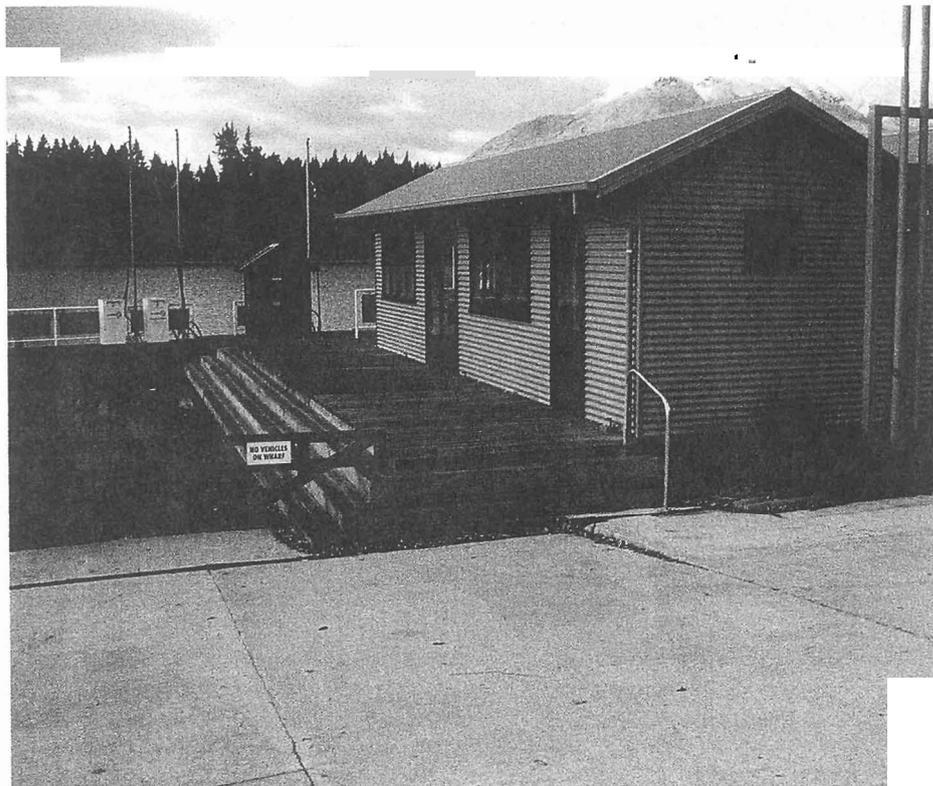
Examples of modifications to building design and fittings, intended to reduce flood risk

and speed up re-instatement, are given below. These are collated from several case studies, notably Dux De Lux Restaurant (at left).

- Drainage channel and submersible pumps: ground floor of building ringed by drainage channel connected to storm water system, acting as barrier to flood waters.

- Isolated stormwater and sewerage services: reflux valves installed on sewerage and stormwater lines where they enter building.
- Perimeter wall construction: reinforced concrete blockwork used.

- Ground floor: 100 mm thick reinforced concrete layer over polythene sheeting.
- Electrical: All electrical wiring run through ceiling or perimeter drainage channel. All power points and switches above flood level. Ground floor slab includes electric heating cables to accelerate drying.

- Floor coverings: easily lifted in case of floods.
- Internal linings and fittings: marine plywood or impermeable materials. Shelving and other fittings movable (e.g. on castors).

- Flood exclusions: watertight doors and windows, sealable to prevent water entering building.
- Exterior areas: landscaped in pavers to mitigate the effects of wave action.
