BY MARJORIE VAN ROON, ECOLOGIST, SENIOR LECTURER, PLANNING DEPARTMENT, UNIVERSITY OF AUCKLAND

MANAGED FLOODING?

INTEGRATED CATCHMENT
MANAGEMENT NEEDED TO
AVOID FLOODING AND
POLLUTION IN
COROMANDEL

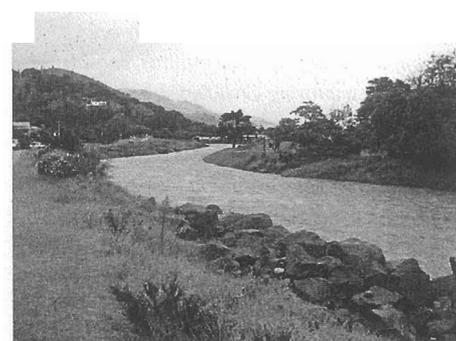
Figure 7: clay discoloured river on the Coromandel Peninsula similar in colour to that causing the damage in Coromandel township.

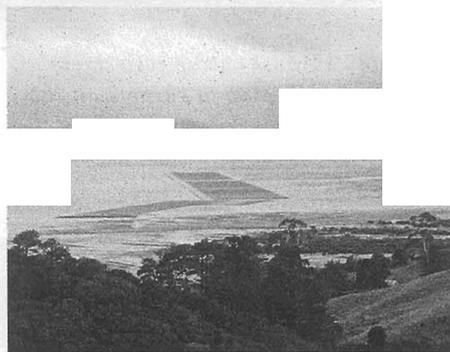
Figure 8 (top): Discolouration of Coromandel Harbours by eroded sediment from land sources.

Figure 9 (bottom): Extensive Coromandel marine farms.

In addition it may be necessary to decline further marine farm applications for leases in Coromandel Harbour or shellfish processing plants dependent on harbour waters for processing, in the vicinity of the river mouth near Hauraki Road.
